## **A FIELD STUDY ON PHOTOLUMINESCENT SIGNAGE USED TO GUIDE BUILDING OCCUPANTS TO EXIT IN COMPLETE DARKNESS**

**Guyène Proulx**, Ph.D., National Research Council of Canada, Ottawa, Canada

A field study was conducted in an office building to assess the effectiveness of photoluminescent material to facilitate occupant evacuation.

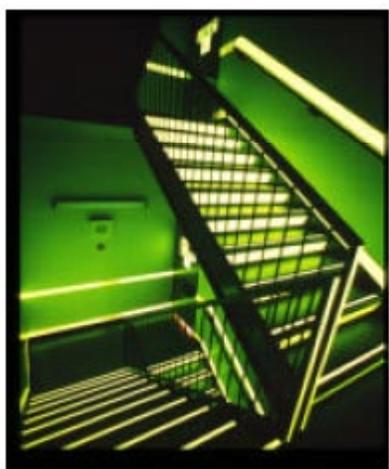
To reduce the lighting, 2 out of 3 double-tube luminaires were switched off, providing Stairwell A with an average lighting of 57 lux and Stairwell D with a slightly higher average output of 74 lux. Also, Stairwell D had PLM signs and a way guidance system installed. Stairwell C also had PLM signs and a way guidance system and had all lights switched off a few minutes before the evacuation, as presented in Figure 1.
